**SCOTTS VALLEY DEVELOPMENT  
VALLEJO, CALIFORNIA**

**PRELIMINARY GEOTECHNICAL EXPLORATION**

**PREPARED BY**  
ENGEO Incorporated

June 19, 2024  
Latest Revision June 27, 2024

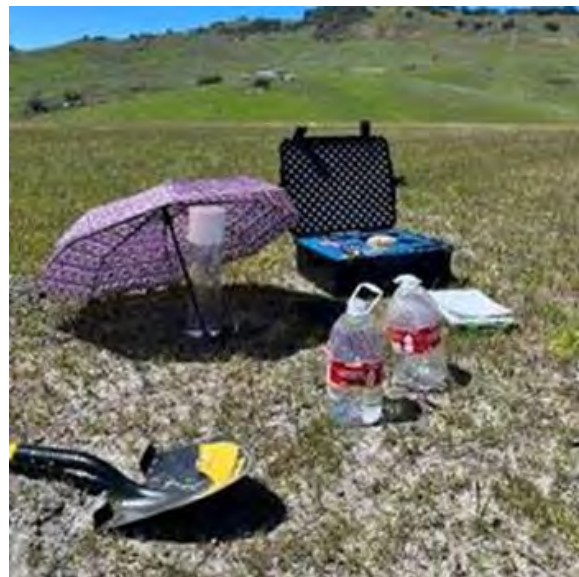
**Photo 2.6.3-1: Infiltration Field Set-Up**

We performed six field infiltration tests within the development area on April 9, 2024, using a Modified Philip Dunne (MPD) Infiltrometer. The MPD tests were performed in general conformance with ASTM D8152-18. Test methods included scarifying the ground surface soil, removing vegetation, and embedding a graduated cylinder to a depth of 2 inches. We covered the test apparatus with an umbrella to prevent it from overheating. The cylinder was filled with approximately 1 gallon of water, and a head drop (fall in the water level in centimeters) was recorded over time.
